Manhole Inspection Summary

Manhole # S19C1_012MH

Location Address: **2601 deering-parksley alley** Cross Street: **tolley-paca ally**

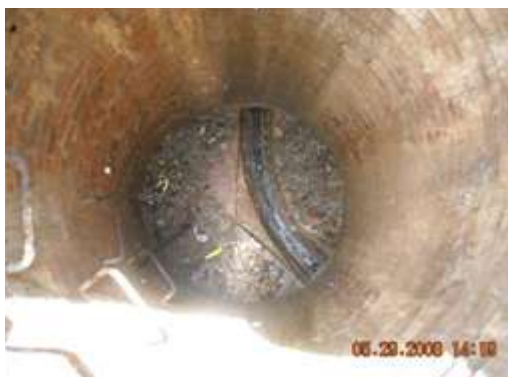
misc

debris on bench

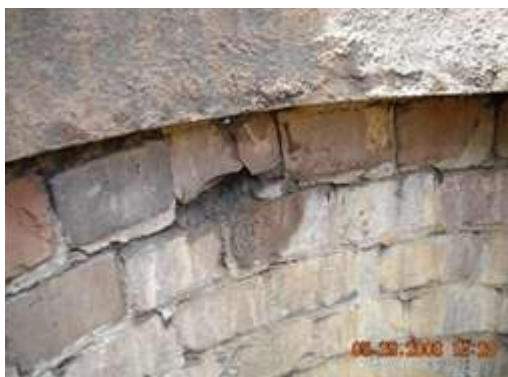
Defect 4

Infiltration: ☐ None ☒ **Joint** ☐ Cracks ☐ Mortar ☐ Roots ☒ **Wall**

infiltration @ corbel wall

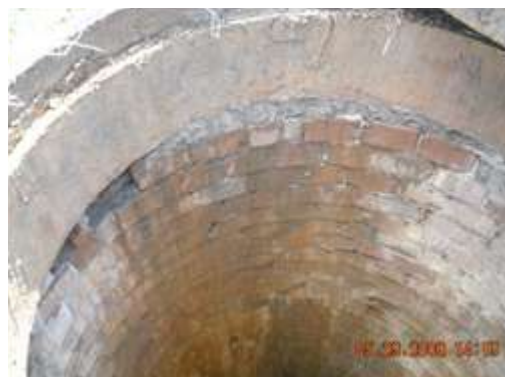
Defect 3

cracked corbel bricks

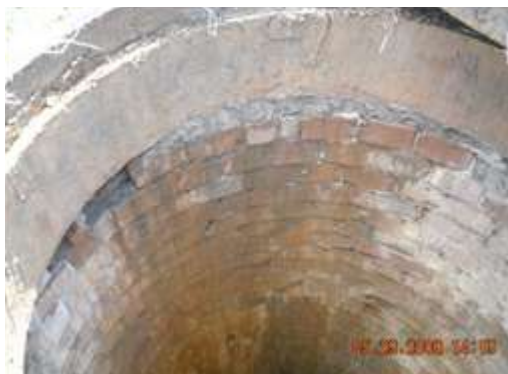
Defect 2

infiltration @ corbel frame joint

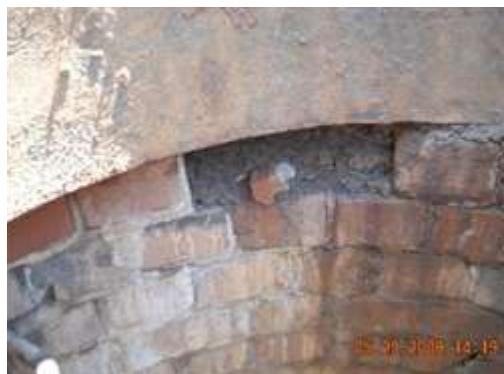
Defect 1

Frame Offset: **1** (in.) Condition: ☒ Sound ☐ Cracked ☐ Leaks

frame offset

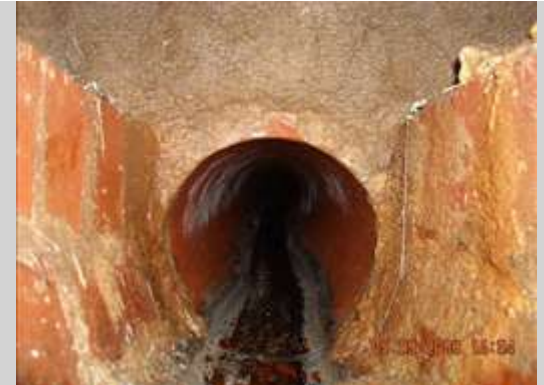
12 O'Clock Outflow

8 in. Circular Gravity Sewer
Pipe Out @ 12 O'Clock

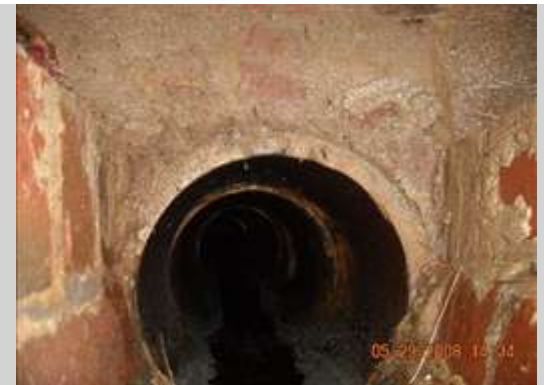
5 O'Clock Inflow

8 in. Circular Gravity Sewer
Pipe In @ 5 O'Clock
